# Team Veolia Improves Dairy Utilities

## Food & Beverage | Case Study

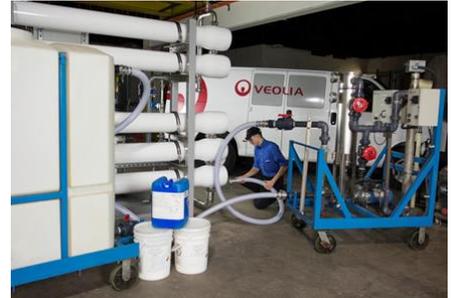
Veolia Team Service performing a Membrane Cleaning on an RO

- Veolia's Team Service began to improve make-up water quality by rebuilding the water softeners and establishing a Preventative Maintenance program for the plant's Reverse Osmosis unit, Filters and Softeners.
- The Boiler and Cooling water systems were automated with Veolia controllers and drumless Hydrex™ feed & storage systems were added.
- Veolia's Hydrex™ Boiler and Cooling water treatment chemistries were introduced, along with more frequent service and Key Performance Indicators (KPIs) established.
- Daily testing protocols were upgraded, and Veolia's cloud based data management software (Veolia VisionNA) was instituted for proactive water management & control.

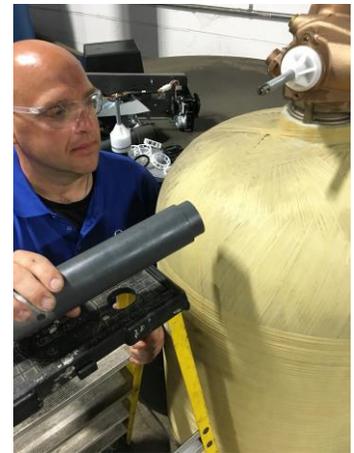
Rebuilding the Control valve on the plant's Softener

- Make-up water quality has improved substantially due to the Softener rebuild, removing hardness more effectively and consistently.
- The Reverse Osmosis unit is operating more efficiently, with output increasing back to within original design flow rate specification.
- Cooling water system corrosion rates are all now < 1 MPY on Mild Steel and < 0.5 MPY on Copper. (Below Right). As well, the Bacterial slimes that were prevalent in the systems are now under control.
- Boiler inspection has revealed the removal of old iron deposits and re-establishment of a gun-black magnetite iron surface. (Below left)
- Plant Maintenance has reduced their number of water related vendors from 3 to 1 with the Veolia team, and they now focus more of their time on production related issues.
